Uniform Mitigation Verification Inspection Form

Inspection Date: April 27, 2023		
Owner Information		
Owner Name: Sharon Stubblebine		Contact Person: Sharon Stubblebine
Address: 301 2nd St N #11		Home Phone:
City: St Petersburg	Zip: 33701	Work Phone:
County: Pinellas		Cell Phone: 813-690-5026
Insurance Company:		Policy #:
Year of Home: 1982	# of Stories: 2	Email: windsong97@earthlink.net

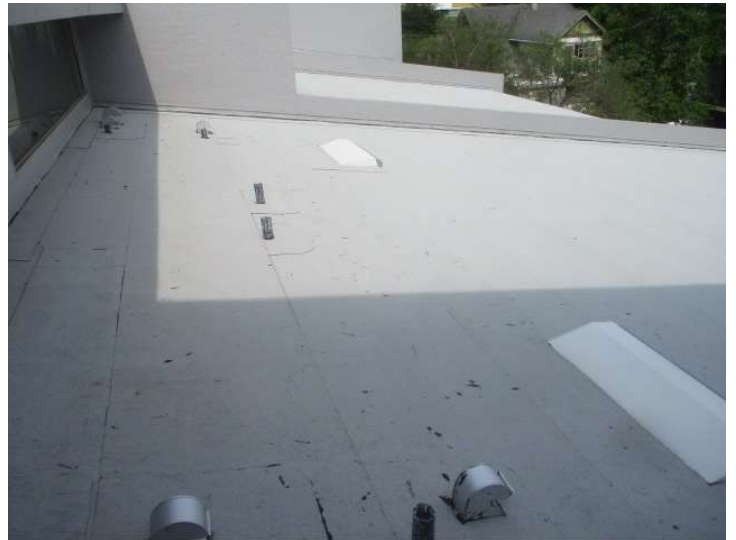
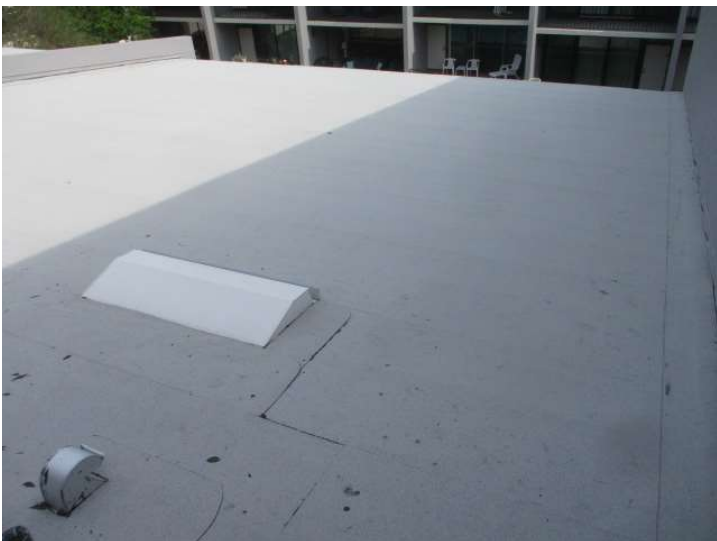
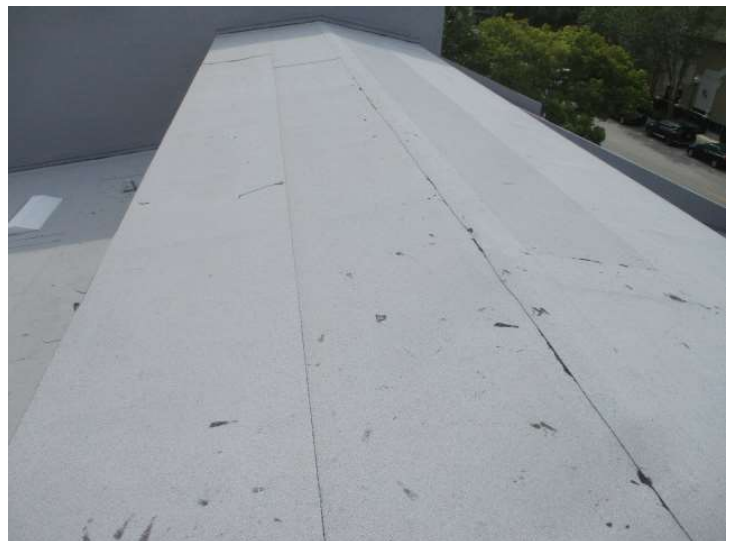
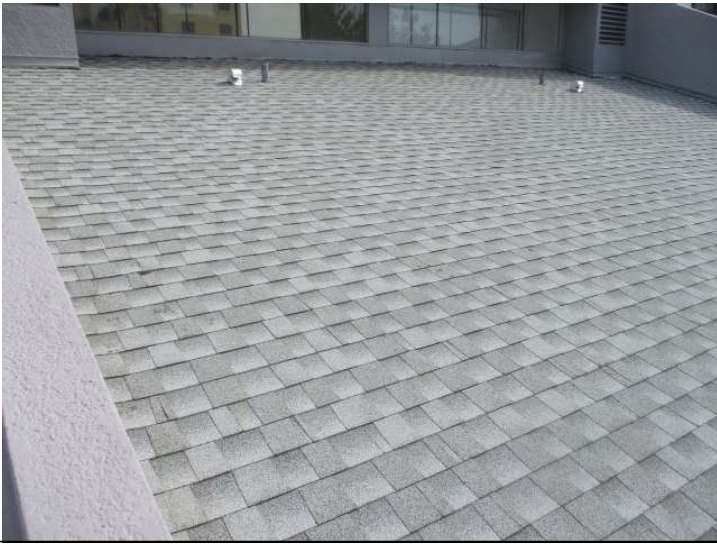
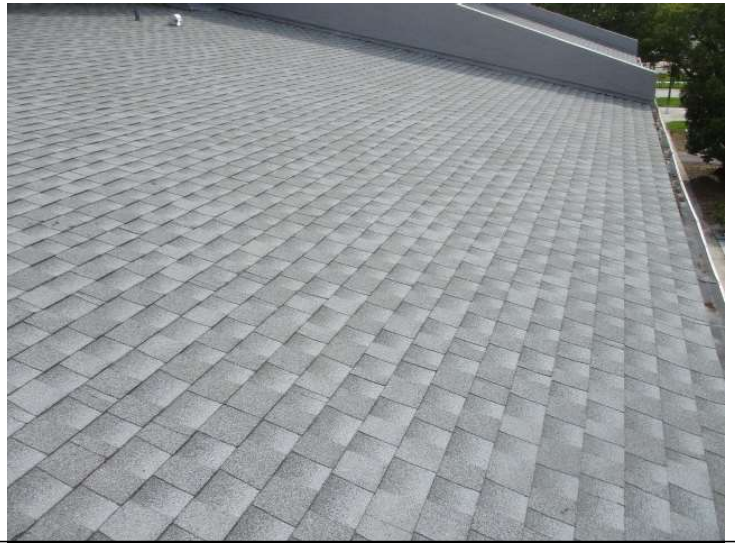
2.1 Roof Covering Type:	Permit Application Date	FBC or MDC Product Approval #	Year of Original Installation or Replacement	No Information Provided for Compliance
<input checked="" type="checkbox"/> 1. Asphalt/Fiberglass Shingle	09/12/2022	2209000665		<input type="checkbox"/>
<input type="checkbox"/> 2. Concrete/Clay Tile				<input type="checkbox"/>
<input type="checkbox"/> 3. Metal				<input type="checkbox"/>
<input type="checkbox"/> 4. Built Up				<input type="checkbox"/>
<input type="checkbox"/> 5. Membrane				<input type="checkbox"/>
<input checked="" type="checkbox"/> 6. Other: Modified Bitumen	09/12/2022	2209000665		<input type="checkbox"/>
