Uniform Mitigation Verification Inspection Form

Inspection Date: November 16, 2022		
Owner Information		
Owner Name: Carol & David Fletcher		Contact Person: David Fletcher
Address: 301 2nd St N #19		Home Phone:
City: St Petersburg	Zip: 33701	Work Phone:
County: Pinellas		Cell Phone: 727-892-0262
Insurance Company:		Policy #:
Year of Home: 1982	# of Stories: 1	Email: daveukus@gmail.com

Site Photos

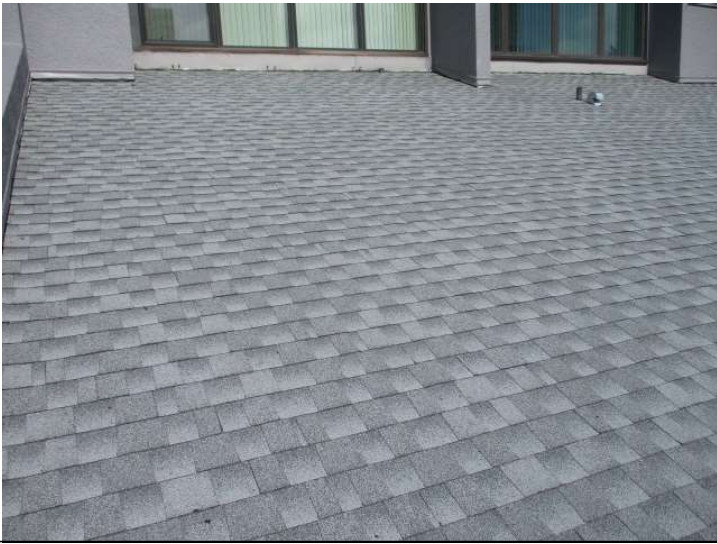
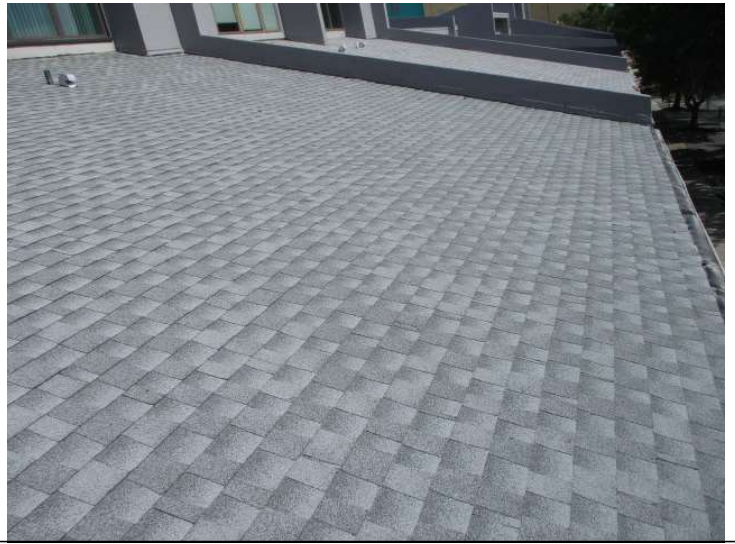
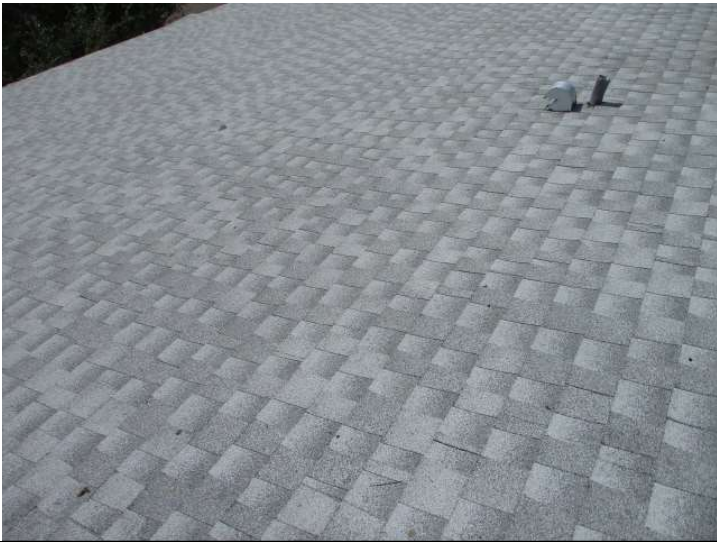
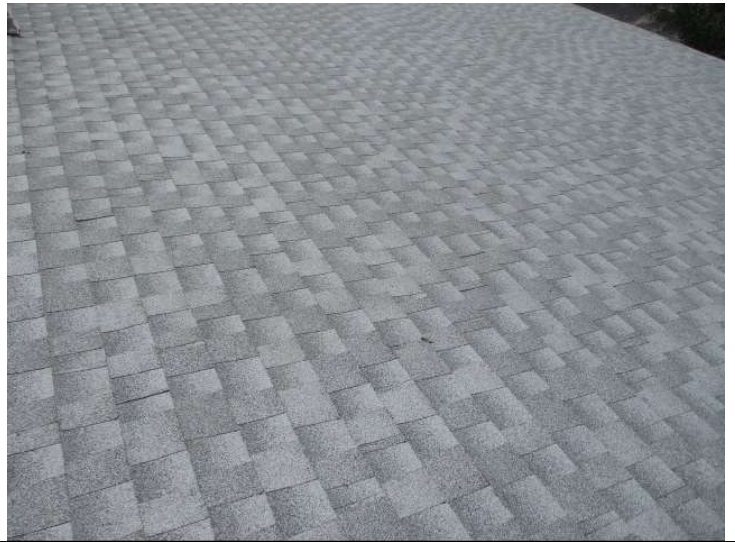
2.1 Roof Covering Type:	Permit Application Date	FBC or MDC Product Approval #	Year of Original Installation or Replacement	No Information Provided for Compliance
<input checked="" type="checkbox"/> 1. Asphalt/Fiberglass Shingle	10/20/2022	2210001314		<input type="checkbox"/>
<input type="checkbox"/> 2. Concrete/Clay Tile				<input type="checkbox"/>
<input type="checkbox"/> 3. Metal				<input type="checkbox"/>
<input type="checkbox"/> 4. Built Up				<input type="checkbox"/>
<input type="checkbox"/> 5. Membrane				<input type="checkbox"/>
<input type="checkbox"/> 6. Other: Modified Bitumen				<input type="checkbox"/>
