Maintain a copy of this form and any documentation provided with the insurance policy

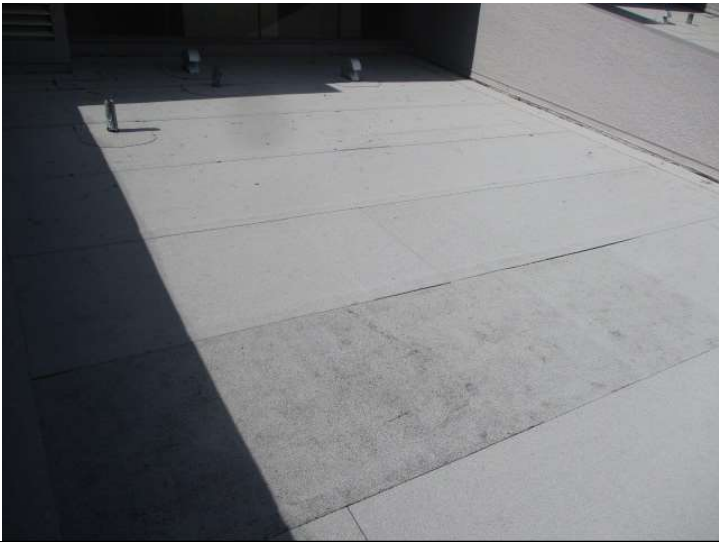
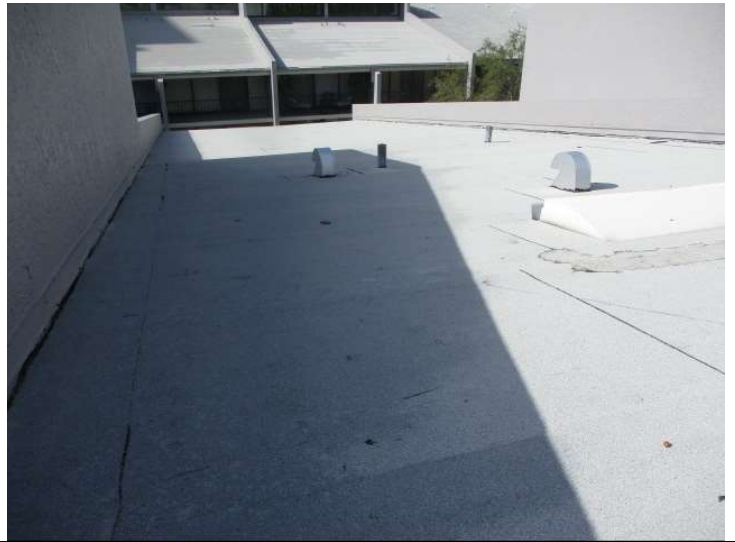
2. **Roof Covering:** Select all roof covering types in use. Provide the permit application date OR FBC/MDC Product Approval number OR Year of Original Installation/Replacement OR indicate that no information was available to verify compliance for each roof covering identified.
