Uniform Mitigation Verification Inspection Form

Inspection Date: August 1, 2023		
Owner Information		
Owner Name: Iris Yetter (Trust)		Contact Person: Iris Yetter
Address: 301 2nd St #7		Home Phone:
City: St Petersburg	Zip: 33701	Work Phone:
County: Pinellas		Cell Phone: 813-534-3613
Insurance Company:		Policy #:
Year of Home: 1982	# of Stories: 3	Email: iyetter@tampabay.rr.com

Inspectors Initial RC Property Address 301 2nd St #7, St Petersburg, FL 33701

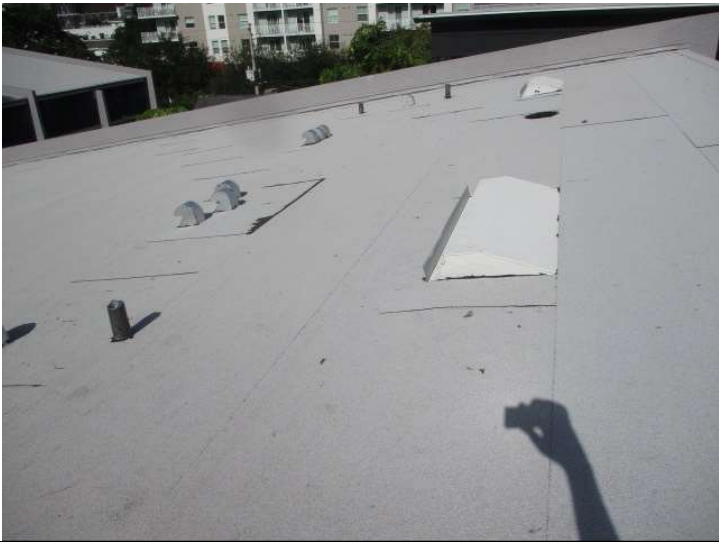
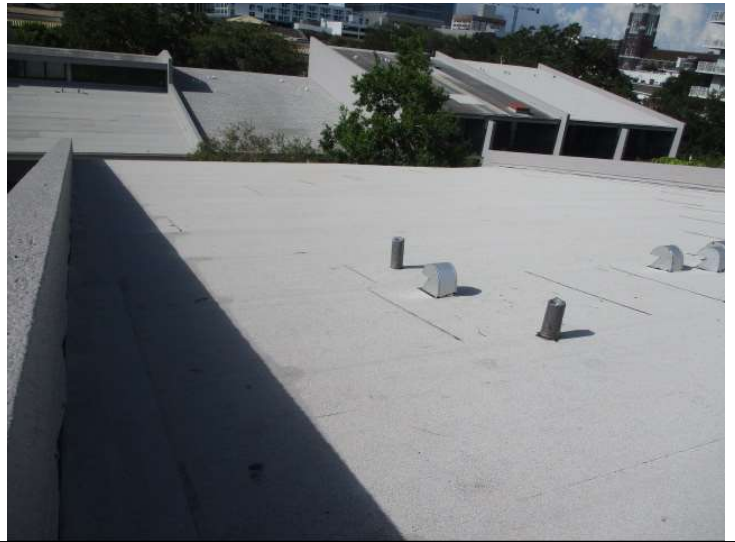
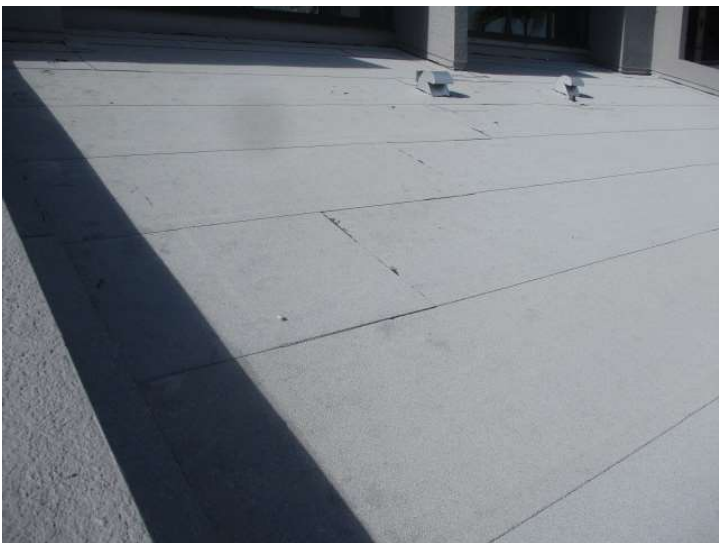
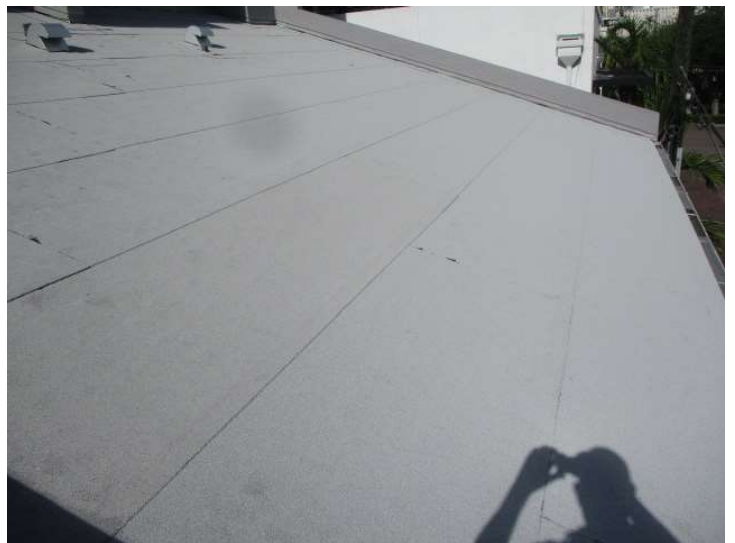
2.1 Roof Covering Type:	Permit Application Date	FBC or MDC Product Approval #	Year of Original Installation or Replacement	No Information Provided for Compliance
<input type="checkbox"/> 1. Asphalt/Fiberglass Shingle				<input type="checkbox"/>
<input type="checkbox"/> 2. Concrete/Clay Tile				<input type="checkbox"/>
<input type="checkbox"/> 3. Metal				<input type="checkbox"/>
<input type="checkbox"/> 4. Built Up				<input type="checkbox"/>
<input type="checkbox"/> 5. Membrane				<input type="checkbox"/>
<input checked="" type="checkbox"/> 6. Other: Modified Bitumen	05/18/2023	235001329		<input type="checkbox"/>

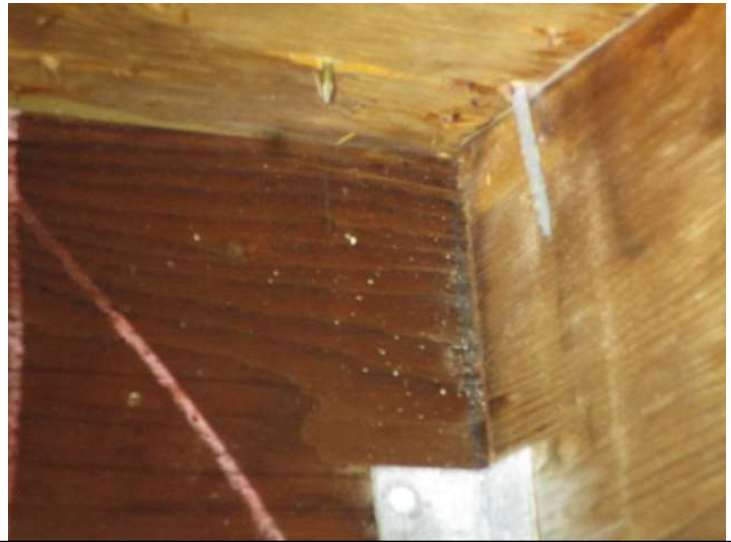
Roof Deck Fastener Size

3. **Roof Deck Attachment:** What is the **weakest** form of roof deck attachment?

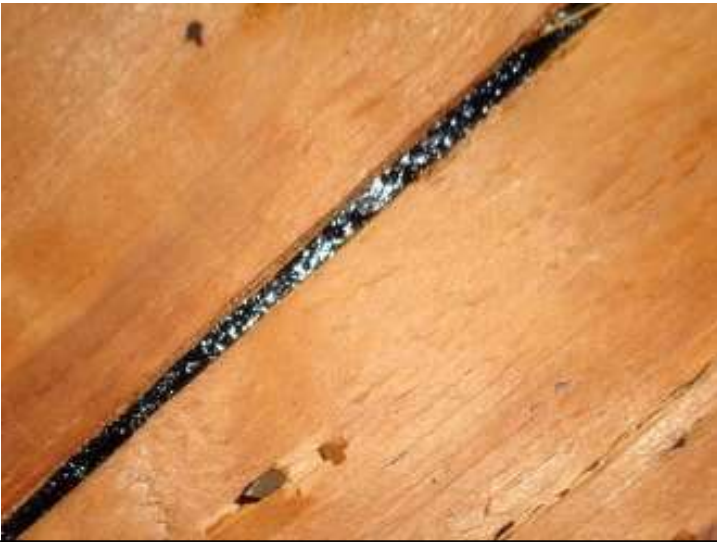
Secondary Water Resistance

6. **Secondary Water Resistance (SWR):** (standard underlayments or hot-mopped felts do not qualify as an SWR)
- SWR (also called Sealed Roof Deck) Self-adhering polymer modified-bitumen roofing underlayment applied directly to the sheathing or foam adhesive SWR barrier (not foamed-on insulation) applied as a supplemental means to protect the dwelling from water intrusion in the event of roof covering loss.
- B. No SWR.
- C. Unknown or undetermined.
7. **Opening Protection:** What is the **weakest** form of wind borne debris protection installed on the structure? **First**, use the table to determine the weakest form of protection for each category of opening. **Second**, (a) check one answer below (A, B, C, N, or X) based upon the lowest protection level for ALL Glazed openings **and** (b) check the protection level for all Non-Glazed openings (.1, .2, or .3) as applicable.

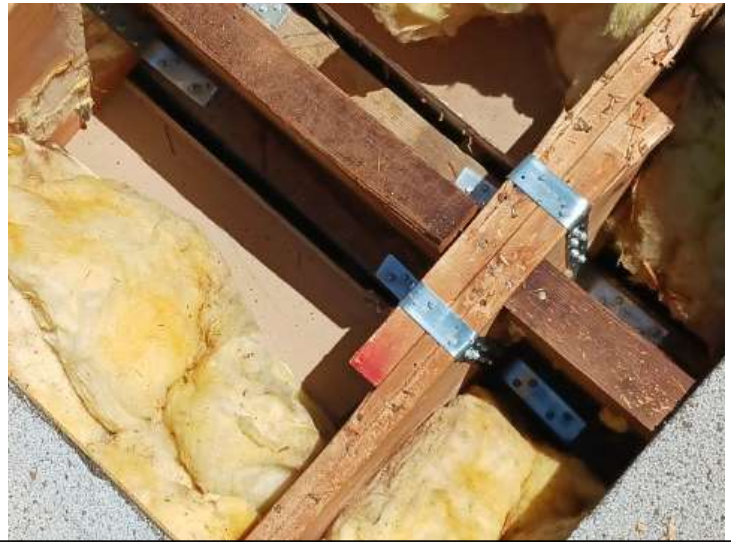
Roof To Wall Connection

4. **Roof to Wall Attachment:** What is the **WEAKEST** roof to wall connection? (Do not include attachment of hip/valley jacks within 5 feet of the inside or outside corner of the roof in determination of WEAKEST type)
