Windstorm Mitigation Report (OIR-B1-1802)

Fareham Square Condominium Association, Inc.

301 2nd St N, Units 2-3

As of 8/6/2021 | FPAT File# MIT2116330

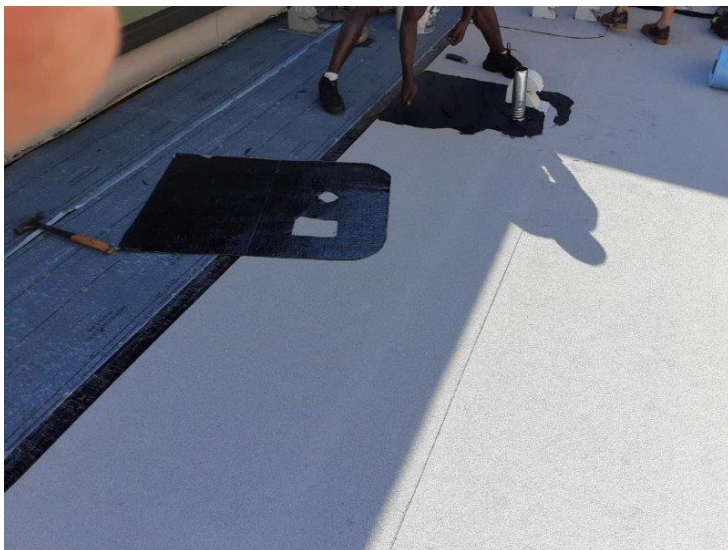
- 3. Roof Deck Attachment:** **Level C**
Comments: Inspection verified 1/2" plywood roof deck attached with 8d nails at a minimum 6" on the edge & 6" in the field.

- 4. Roof to Wall Attachment:** **Clips**
Comments: Inspection verified hurricane clips fastened with a minimum of three nails.
- 5. Roof Geometry:** **Other Roof**
Comments: Inspection verified a gable roof shape.

Roof Construction
