Windstorm Mitigation Report (OIR-B1-1802)

Fareham Square Condominium Association, Inc.

301 2nd St N, Units 8-9

As of 8/6/2021 | FPAT File# MIT2116330

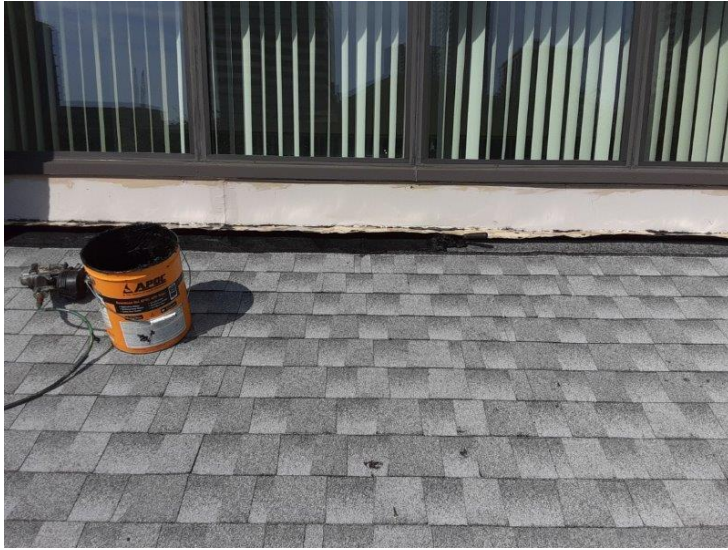
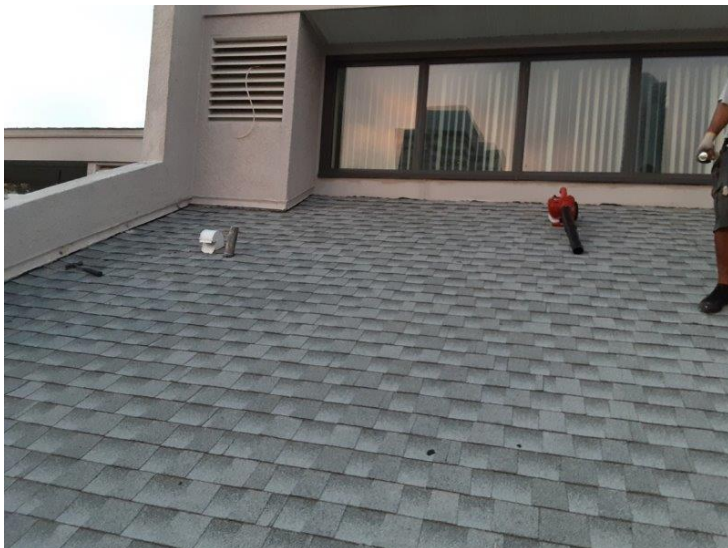
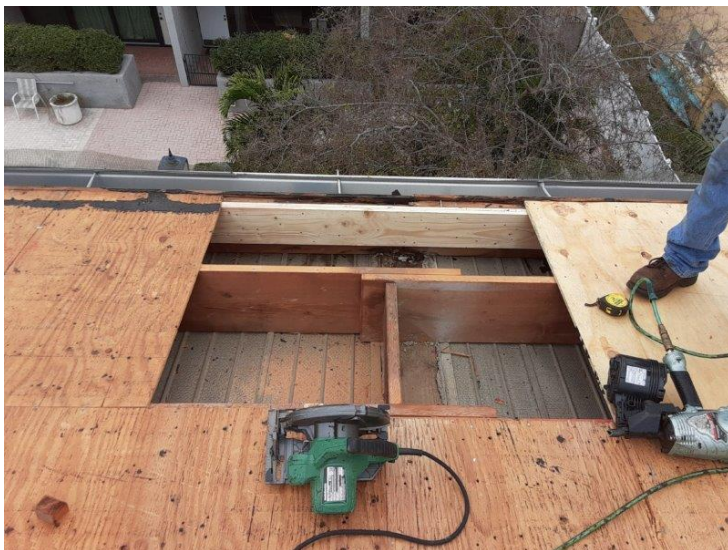
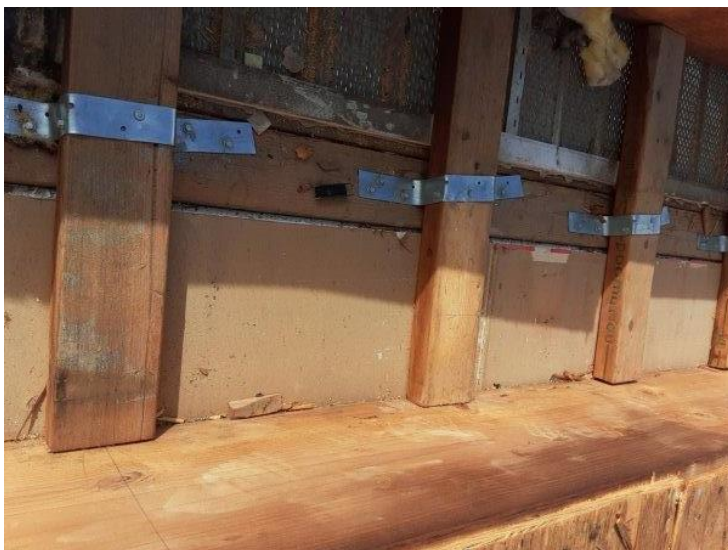
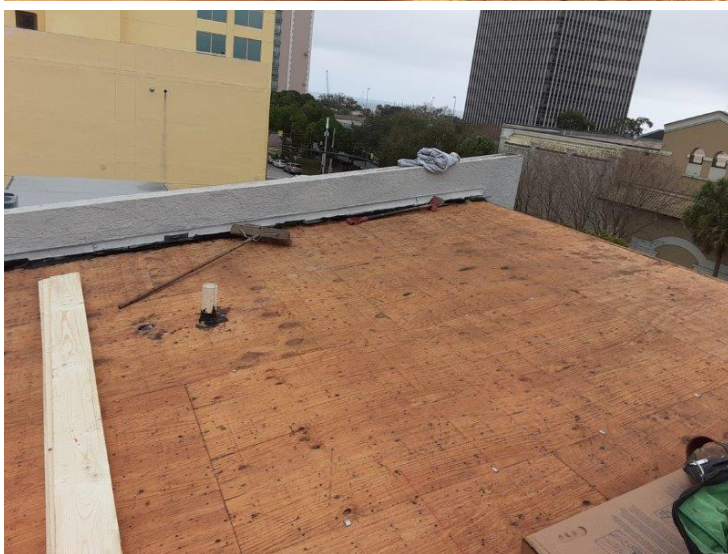
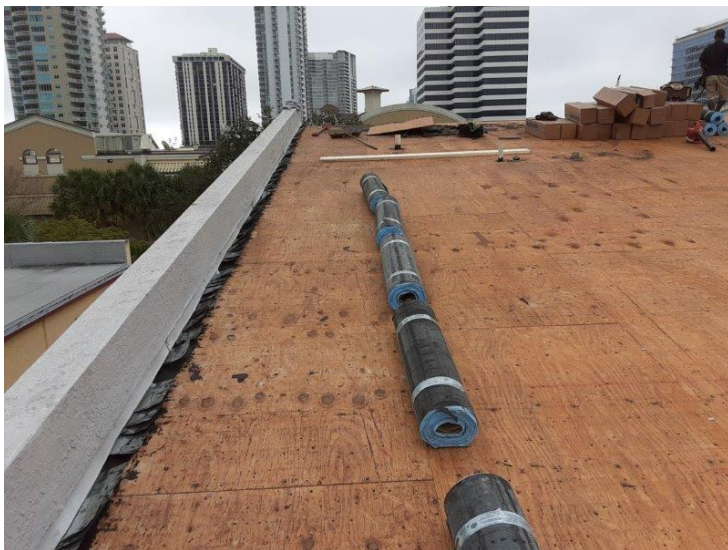
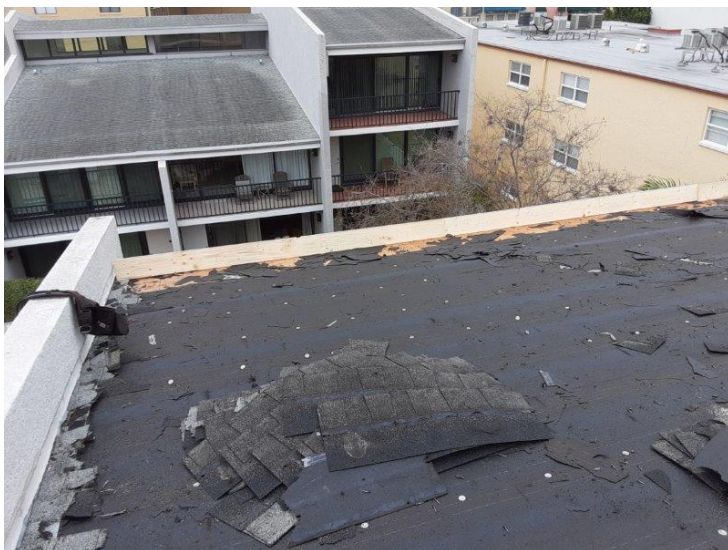
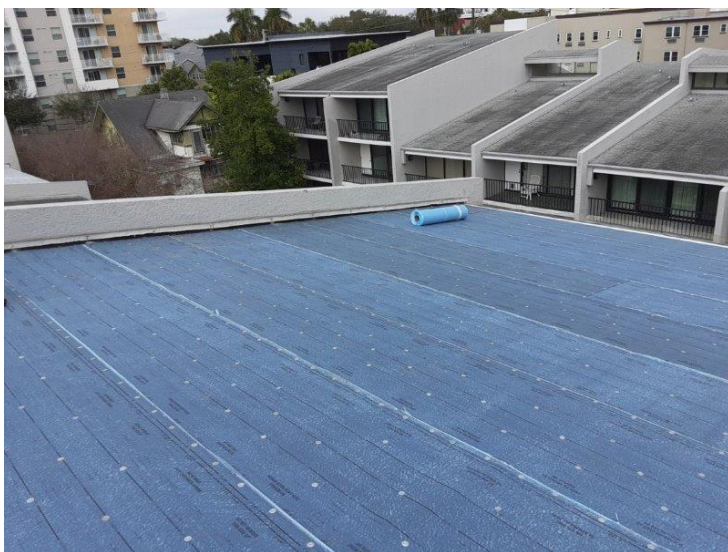
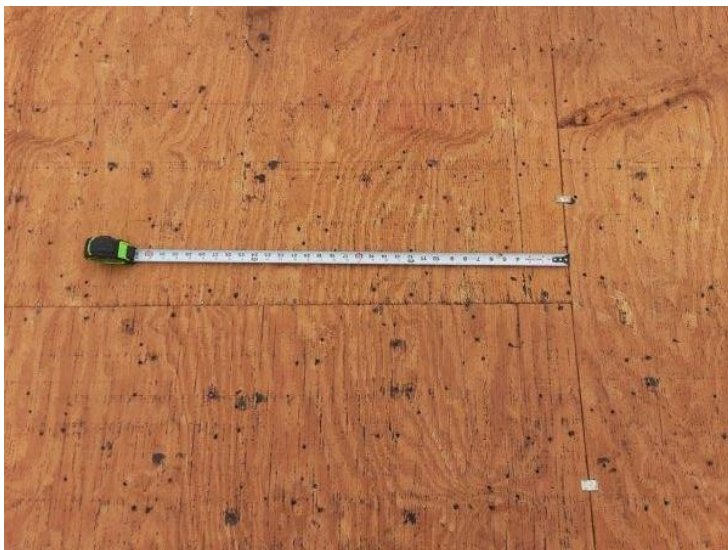
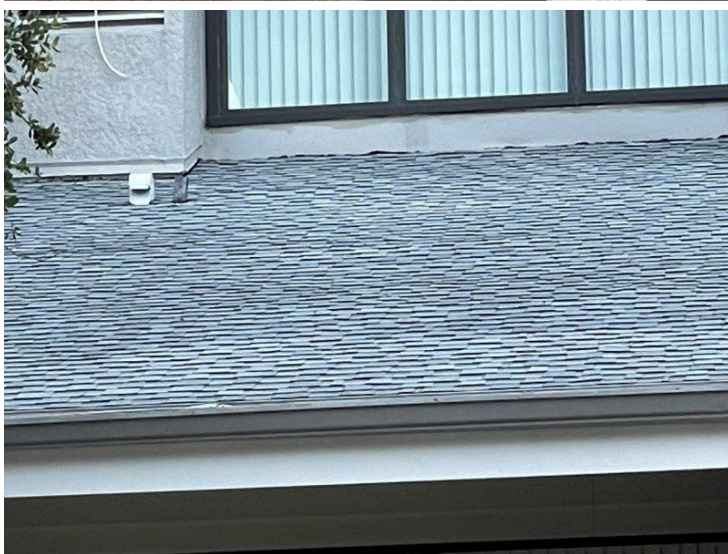
- 3. Roof Deck Attachment:** **Level C**
Comments: Inspection verified 1/2" plywood roof deck attached with 8d nails at a minimum 6" on the edge & 6" in the field.

- 4. Roof to Wall Attachment:** **Clips**
Comments: Inspection verified hurricane clips fastened with a minimum of three nails.
- 5. Roof Geometry:** **Other Roof**
Comments: Inspection verified a gable roof shape.

- 6. SWR:** **Yes**
Comments: SWR was verified at time of inspection. The Secondary Water Resistance verified is a self-adhering peel and stick.
- 7. Opening Protection:** **None or Some Glazed Openings**
Comments: Inspection verified some opening protection. Not all glazed openings were protected with impact resistant coverings.

Roof Construction
