COMMERCIAL WINDSTORM MITIGATION REPORT

Fareham Square Condominium Association, Inc.

As of 7/22/2019

FPAT File# MIT1911527

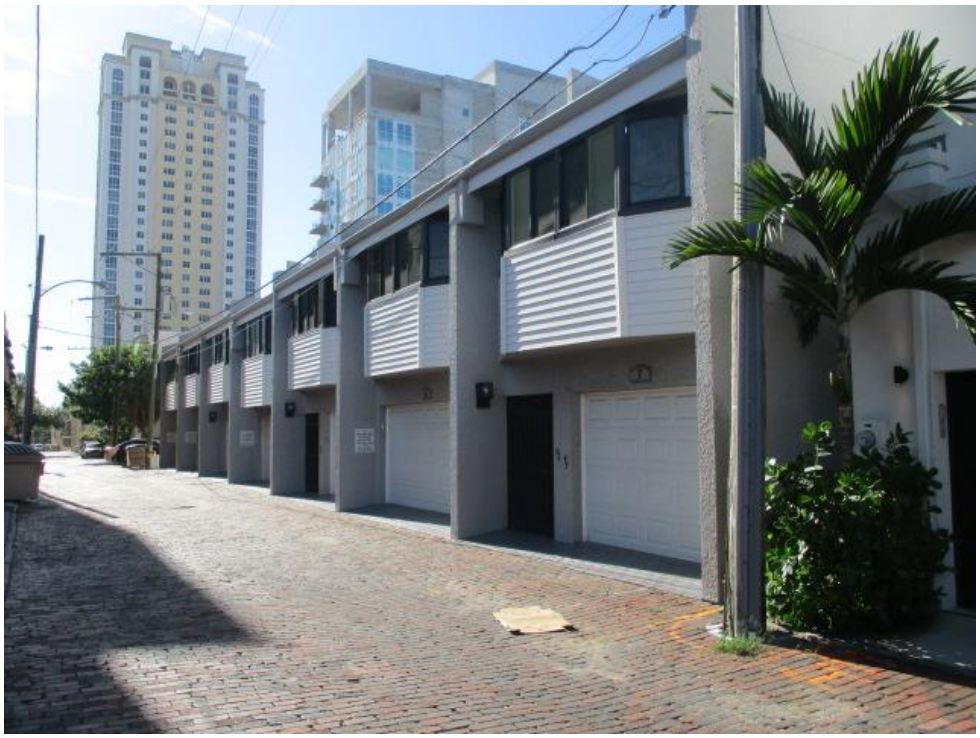
301 2nd St N, Building A, Units 1-7

2.	**Roof Covering:**	**FBC Equivalent**
	Comments:	The roof covering was replaced in 2006. The roof permit was confirmed and the permit number is 06-4000775 This roof was verified as meeting the building code requirements outlined on the mitigation affidavit.

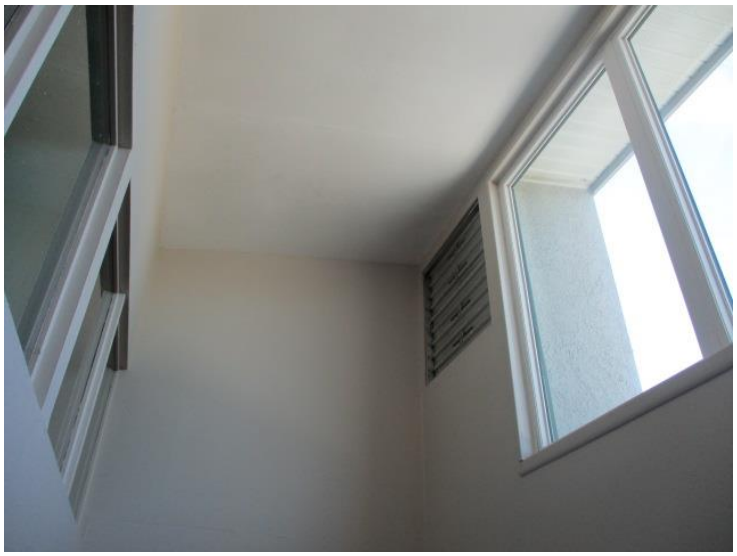
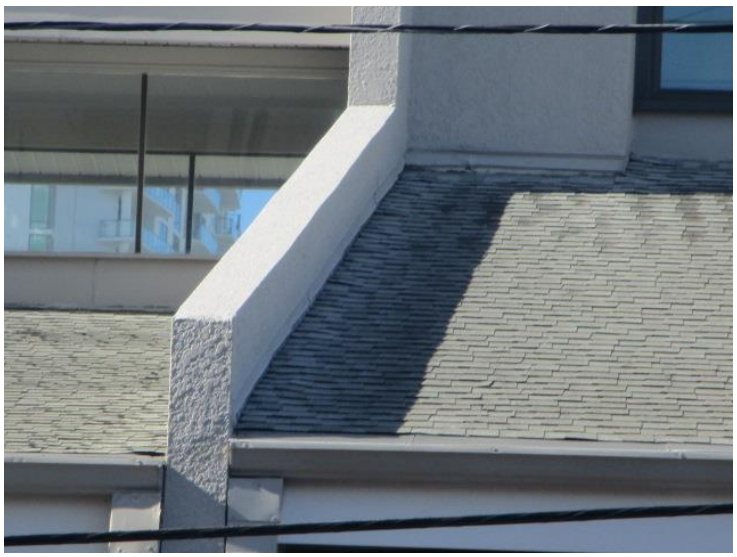
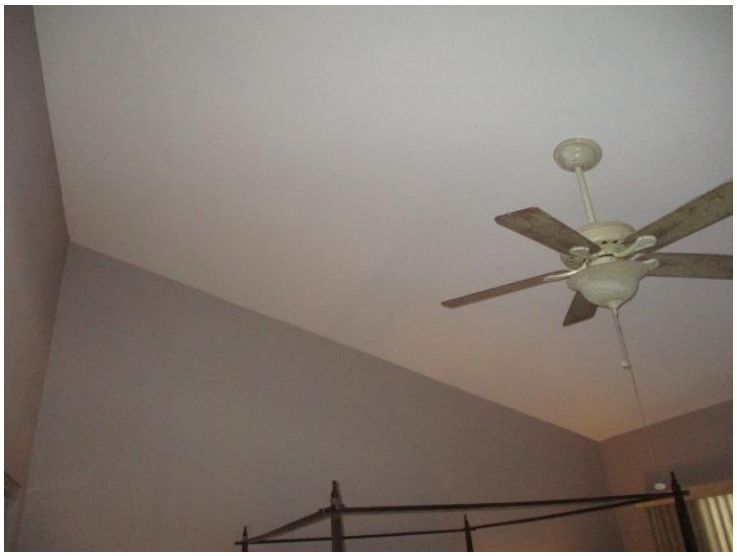
Roof Construction

5.	**Roof Geometry:**	**Other Roof**
	Comments:	Inspection verified a gable roof shape.
6.	**SWR:**	**Unknown or Undetermined**
	Comments:	Due to no attic access we were unable to verify SWR.

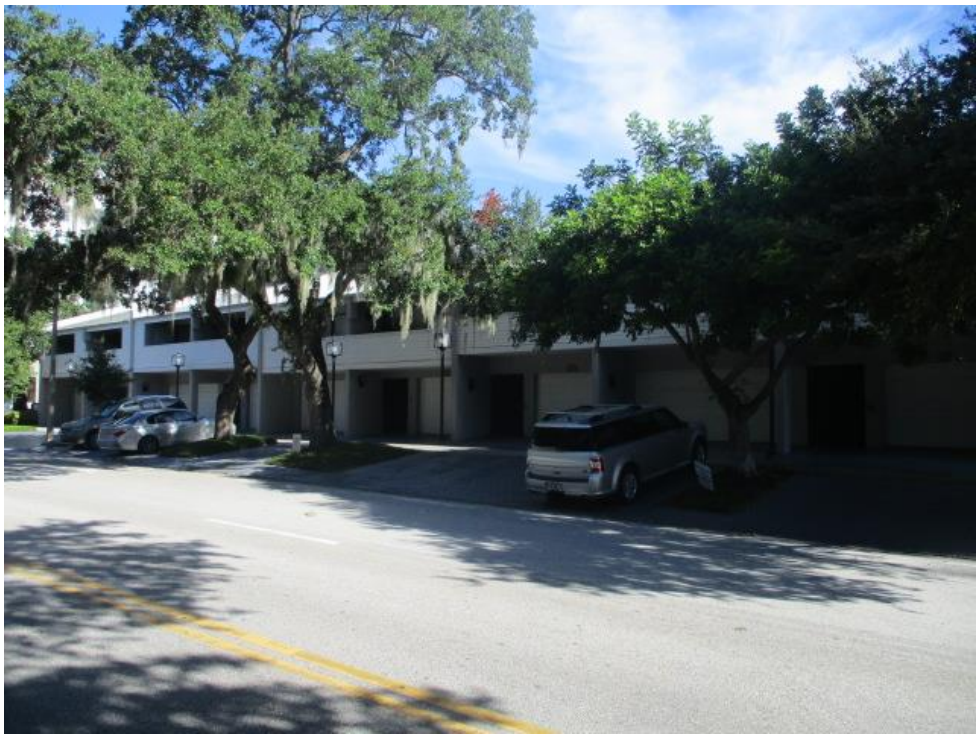
301 2nd St N, Building B, Units 8-19

2.	**Roof Covering:**	**FBC Equivalent**
	Comments:	The roof covering was replaced in 2006. The roof permit was confirmed and the permit number is 06-4000776 This roof was verified as meeting the building code requirements outlined on the mitigation affidavit.

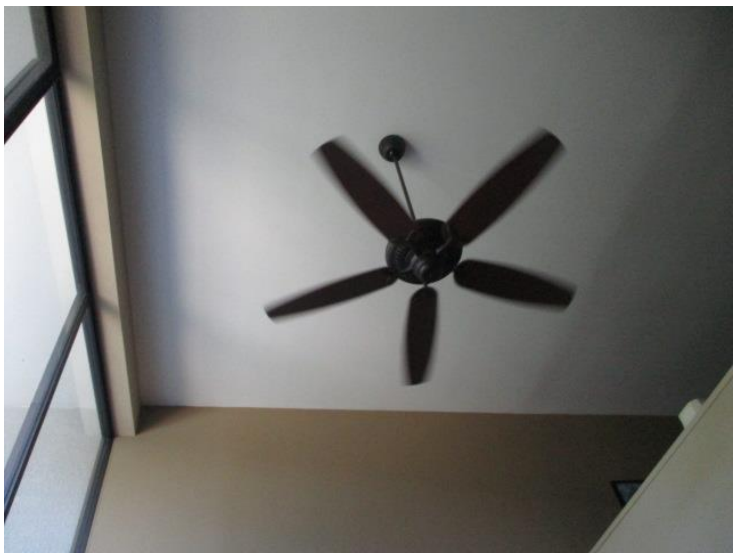
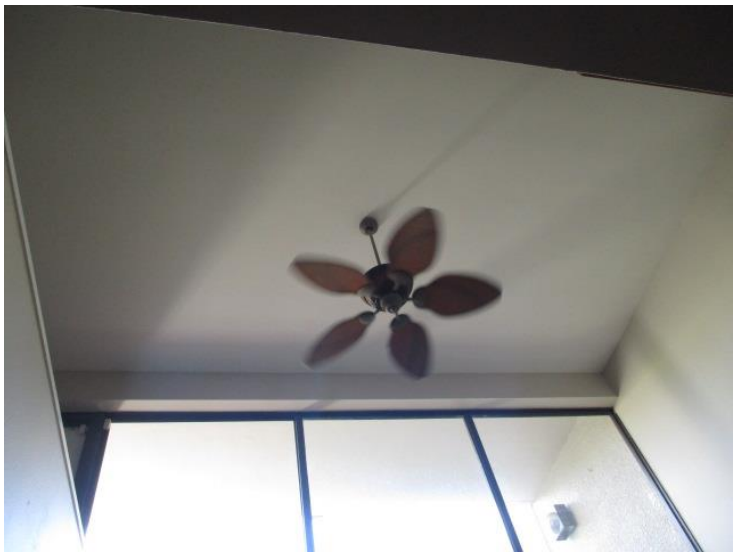
Roof Construction

5.	**Roof Geometry:**	**Other Roof**
	Comments:	Inspection verified a gable roof shape.
6.	**SWR:**	**Unknown or Undetermined**
	Comments:	Due to no attic access we were unable to verify SWR.
